**U.S. Department of Transportation
Pipeline and Hazardous Materials Safety Administration (PHMSA)
Office of Pipeline Safety**

**Preliminary Factual Report
Plains Pipeline, LP, Failure on Line 901**

February 2016

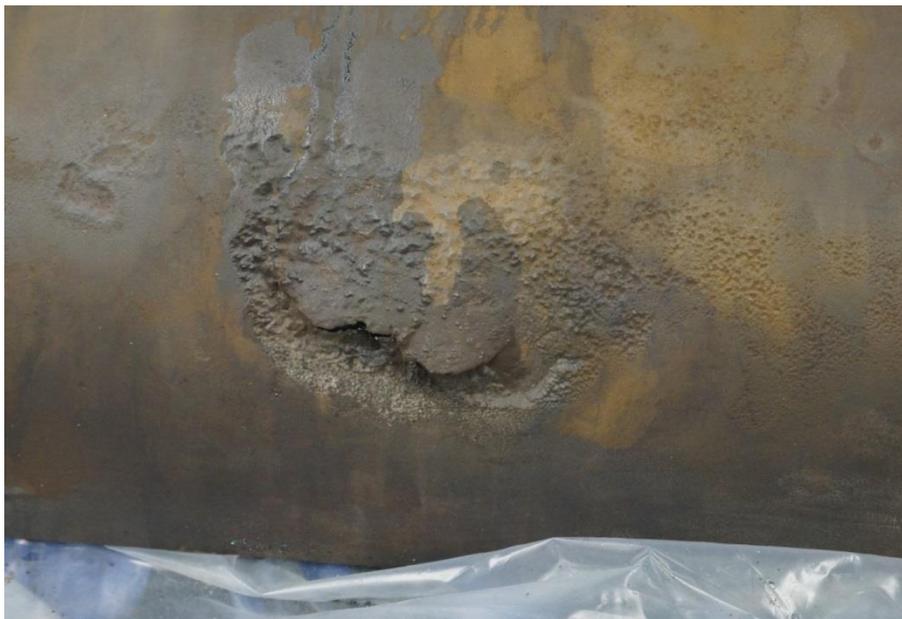
Pipe External Surface at the Line 901 Failure Site

“The results of the metallurgical analysis indicate that the leak occurred at an area of external corrosion that ultimately failed in ductile overload under the imposed operating pressure. The morphology of the external corrosion observed on the pipe section is consistent with corrosion under insulation facilitated by wet-dry cycling.”

The May 6, 2015 ILI survey data indicated corrosion at the failure site with an area of 5.38 inches by 5.45 inches, and a maximum depth of 47%. The DNV-GL metallurgical analysis physically measured corrosion at the failure site to have a maximum depth of 86%.³
